MARINE INVESTIGATION REPORT

M16P0378

Grounding and subsequent sinking

Tug *Nathan E. Stewart* and tank barge *DBL 55*

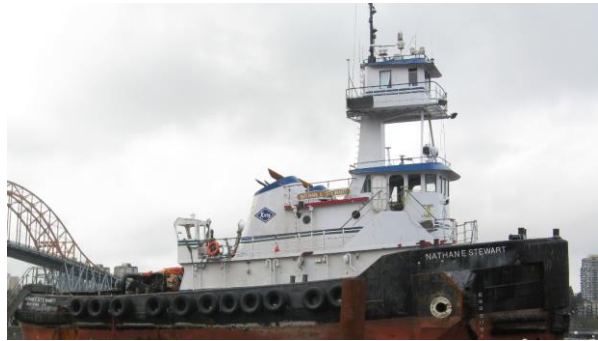
Figure 1. The *Nathan E. Stewart*

The *Nathan E. Stewart* was a conventional harbour and deep-sea towing tug of steel construction (Figure 1). It had an upper and lower wheelhouse for navigating. The upper wheelhouse could be accessed through an internal stairwell from the lower wheelhouse. It had an open layout, with windows that provided a nearly all-around, unobstructed view, and there was a chair in the middle of the space. The navigation of the tug was normally conducted from the upper wheelhouse.

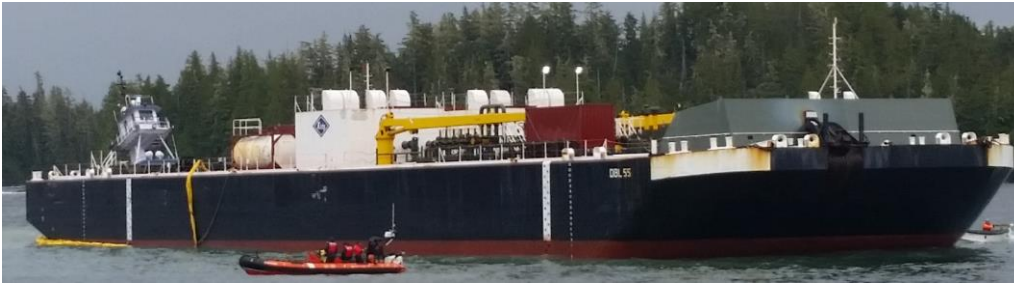
Figure 2. Tank barge *DBL 55*

The *DBL 55* is a double-hulled⁴ tank barge with 14 cargo tanks, and is certified to carry 52 000 barrels⁵ with a maximum displacement of approximately 11 000 long tons.⁶ It is also certified to carry 116 long tons of deck cargo. On deck, the barge is equipped with 2 diesel oil service tanks, 2 holding tanks, and 300 m of pollution boom and absorbent pads. It has a raked bow designed for ease of movement in sea conditions and a 9.7 m deep V-shaped indent at the stern to accommodate the bow of a pushing tug (Figure 2).

When the *Nathan E. Stewart* is in pushing mode, the bow of the tug is secured to the V-shaped indent at the stern of the barge with pneumatically operated pins. These pins create a hinge between the tug and the barge that allows for their differing movements during transit. When the 2 vessels are connected in this manner, they become an articulated tug-barge (ATB).

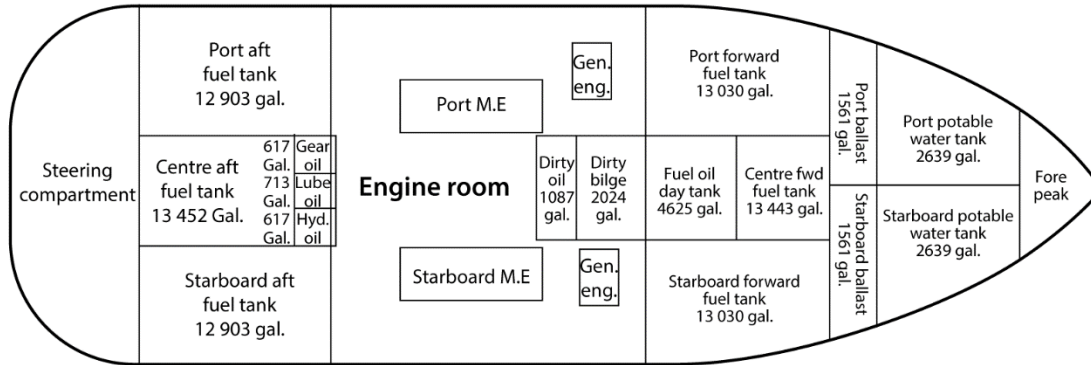
Appendix A – General arrangement of the Nathan E. Stewart

95' 3" X 32' X 18' 9"
 TWIN SCREW TUG
 BUILT 2001
 Hope Services, LA
 OFFICIAL No 1120997
 HULL Number 142
 HP 3200

CAPACITY SUMMARY
 FUEL OIL.....88 664 gal.
 LUBE OIL.....713 gal.
 BALLAST, FWD.....3122 gal.
 POT. WATER.....5278 gal.

Below the main deck was the fore peak, storage compartment, engine room, and steering compartment. The port and starboard pneumatically operated pins, which were used to connect the tug and barge, were located in the storage compartment. There were also 3 aft and 4 forward fuel tanks, as well as additional oil tanks for lubricant, gear oil, hydraulic oil, used oil, and bilge water (Appendix A).³
